CONTINUING ELIGIBILITY INSPECTION (CEI) REPORT
FOR HURRICANE & SHORE PROTECTION PROJECTS
Honolulu Engineer District
CEPOH-EC-T

1. Project Name: Ali'i Drive SPP
2. Date of Inspection: December 17, 2004
3. Inspection Personnel:

The project, completed in January 2000, provided for the repairs of a 705 LF seawall with grout bags to fill / repair the voids along the toe of the structure. Mr. Dale Gomes, the DPW representative attended this inspection. NOTE: Inactive gas pipes are located every 50 ft. Photographs and deficiencies are listed below.

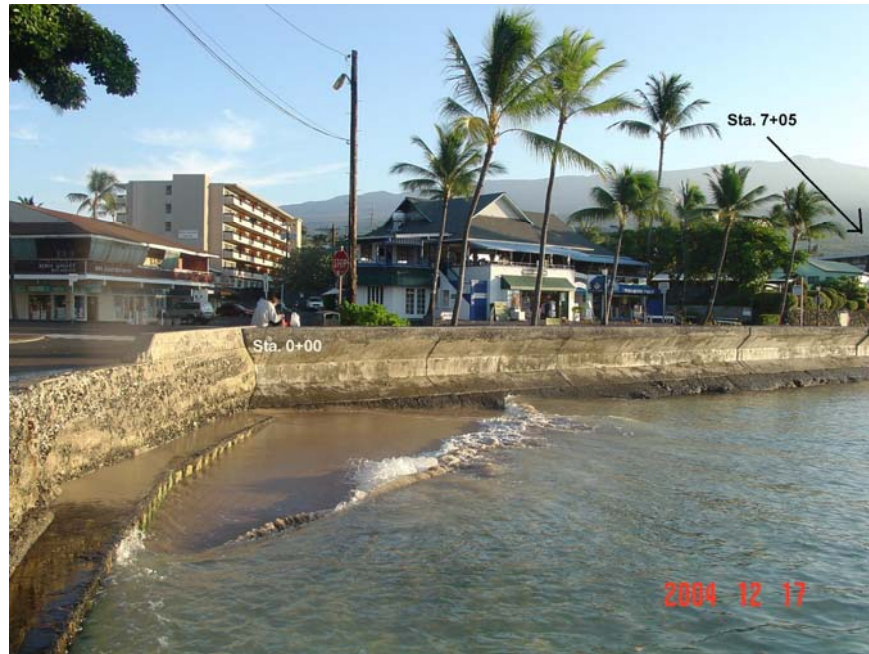
a. Sta. 0+00, Overview of the project (reference photo).

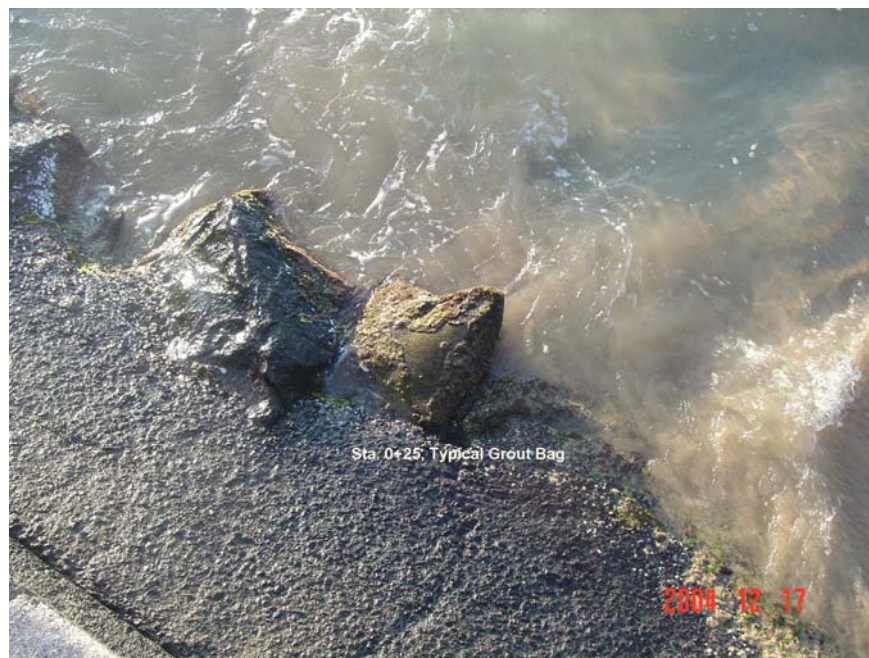
b. Sta. 0+25, Typical grout bags (reference photo).

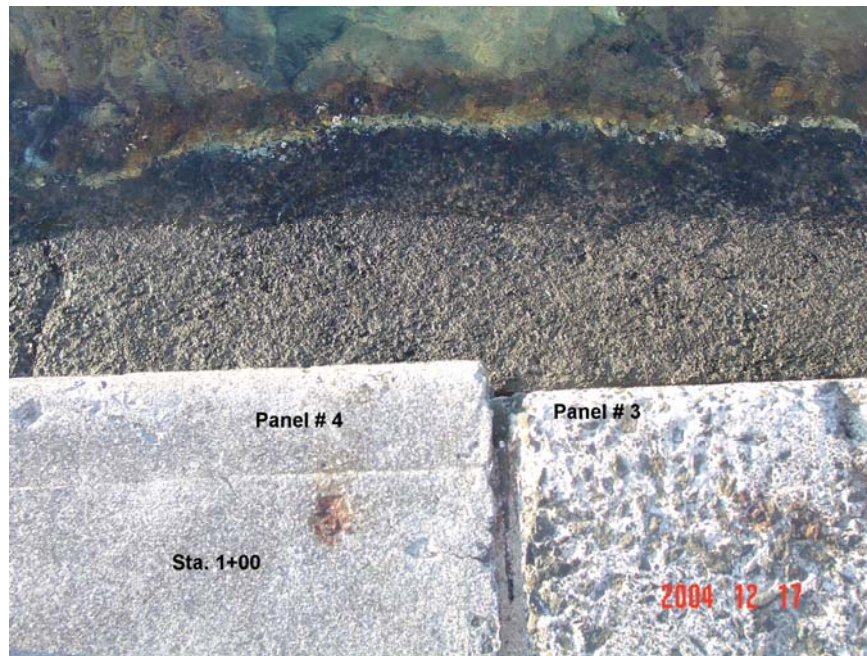
- c. Sta. 1+00, Panel # 4, Monitor the crest separation. This is an existing condition (reference photo). No Change.

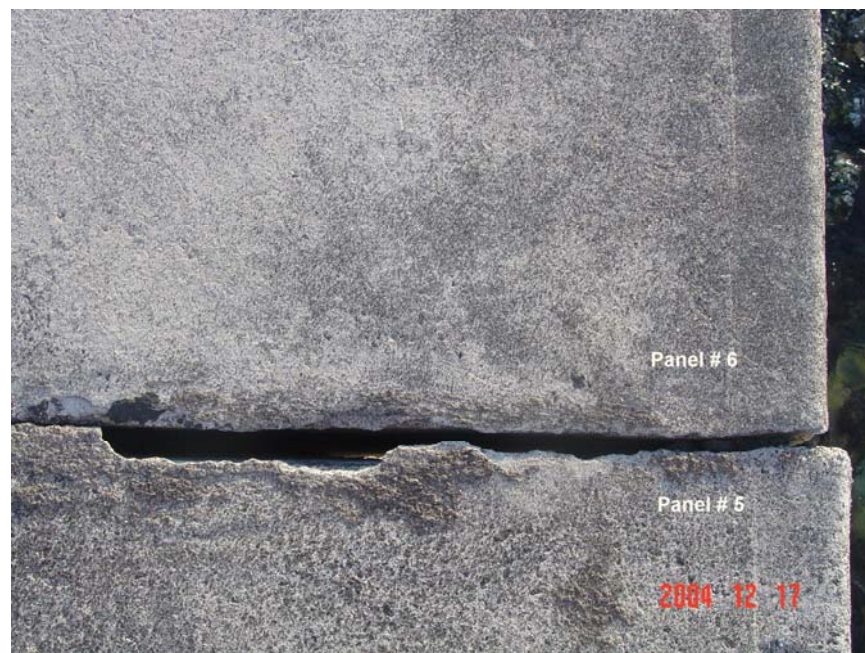
- d. Sta. 1+75, Panel # 5, Monitor the crest separation. This is a new condition (reference photo).

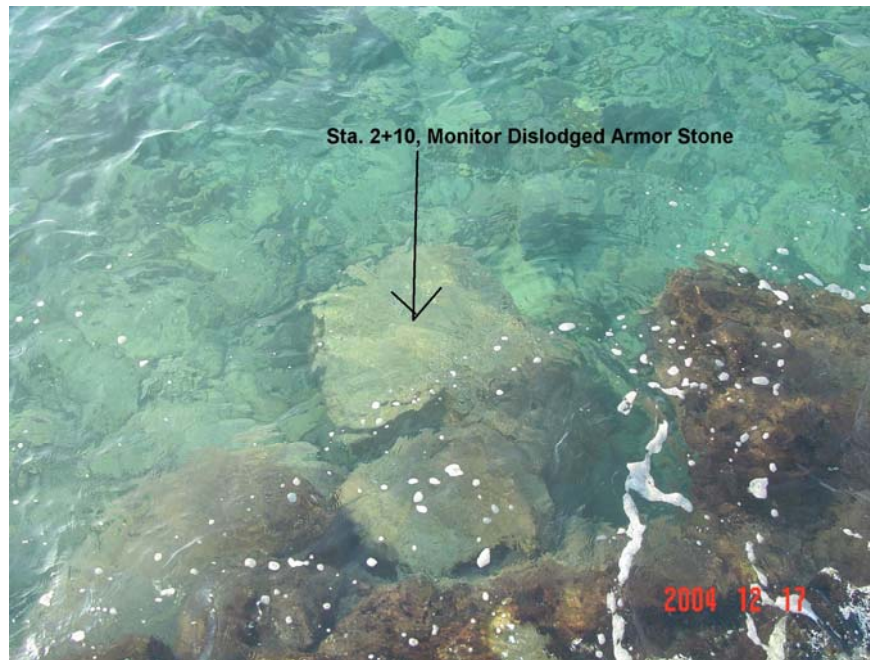
e. Sta. 2+10, Monitor the dislocated armor toe stone in this area.

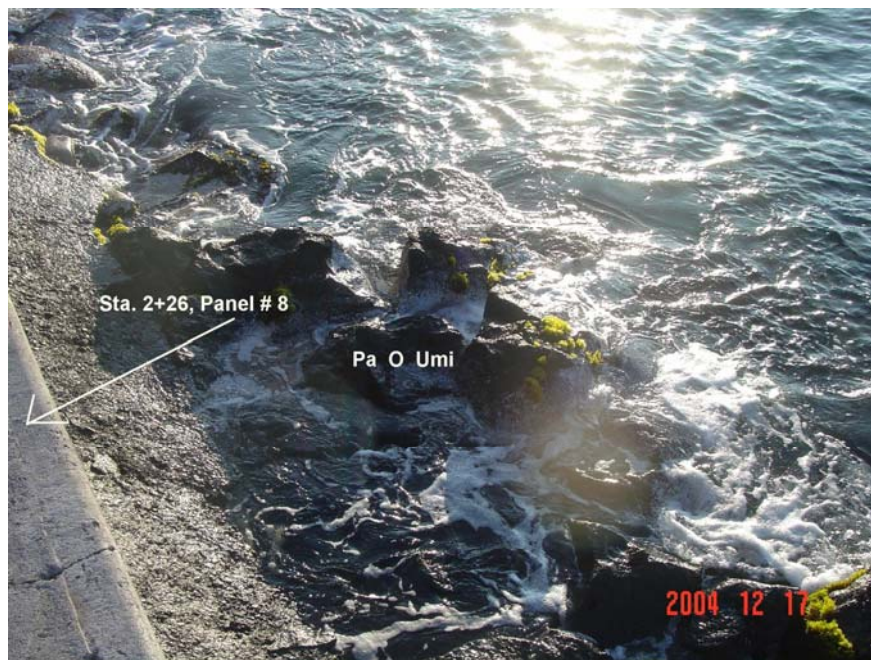
f. Sta. 2+26, Historical Landmark, "Pa O Umi" , no work within 5 feet either side (reference photo).

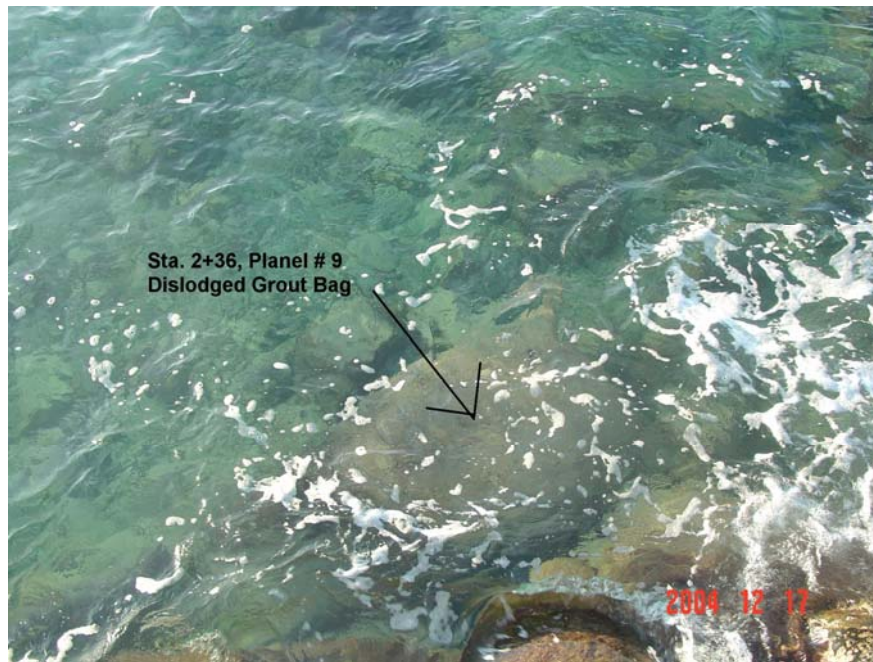
g. Sta. 2+36, Monitor this area for movement, 1 ea. dislocated grout bag.

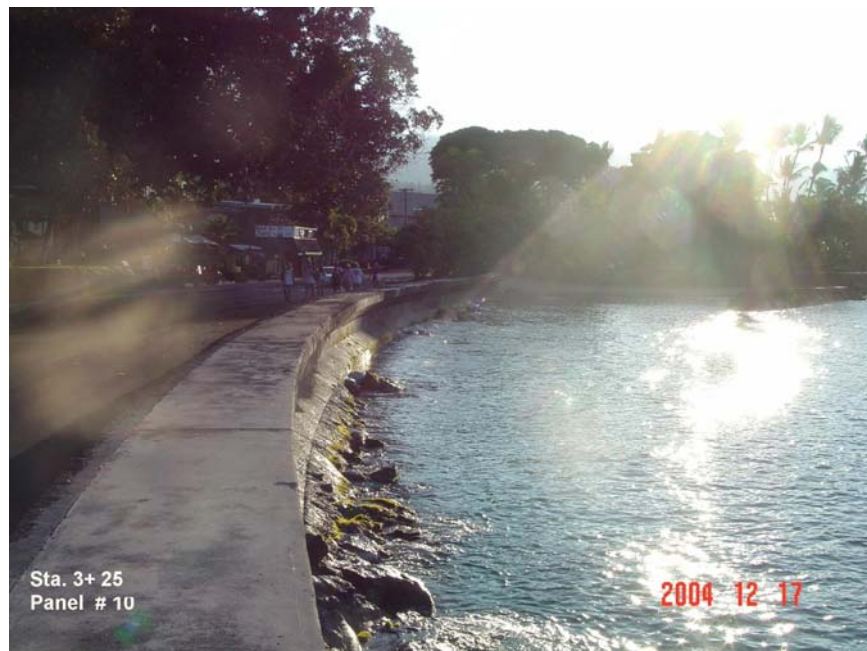
h. Sta. 3+25, Panel # 10, Overview (reference photo).

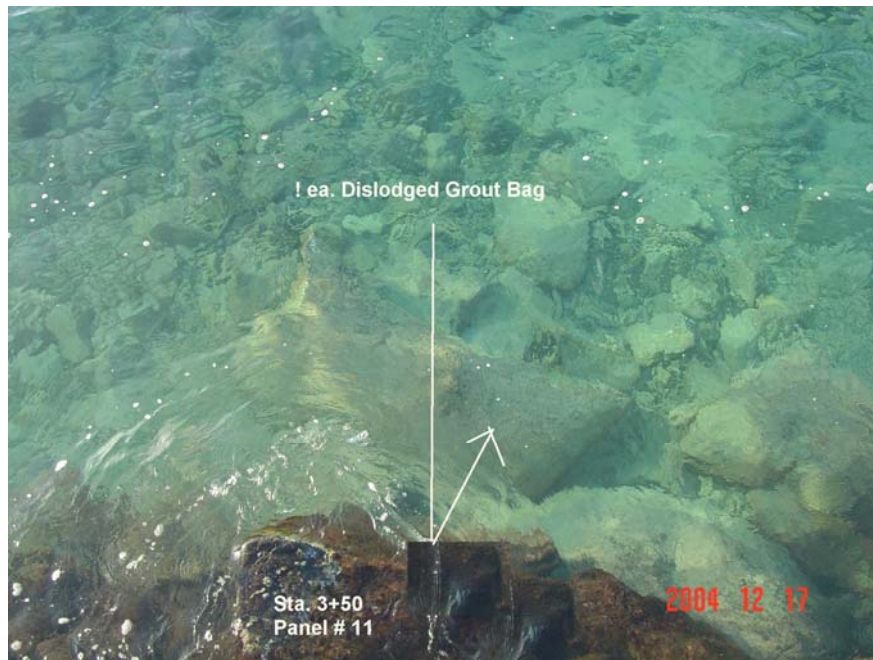
- i. Sta. 3+50, Panel # 12, 1 ea. Dislodged grout bag, monitor high wave energy area.

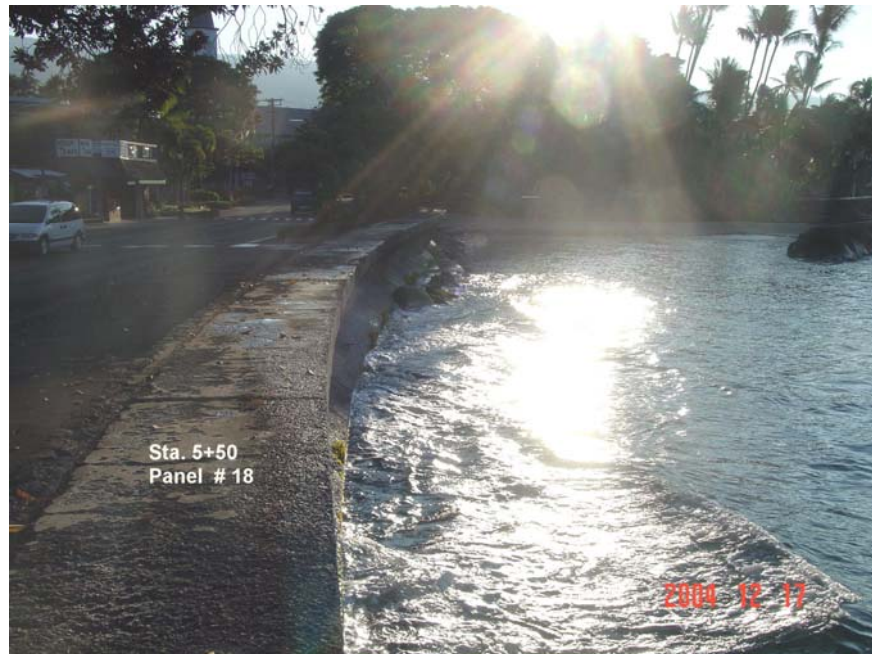
- j. Sta. 5+50, Panel # 18, Overview (reference photo).

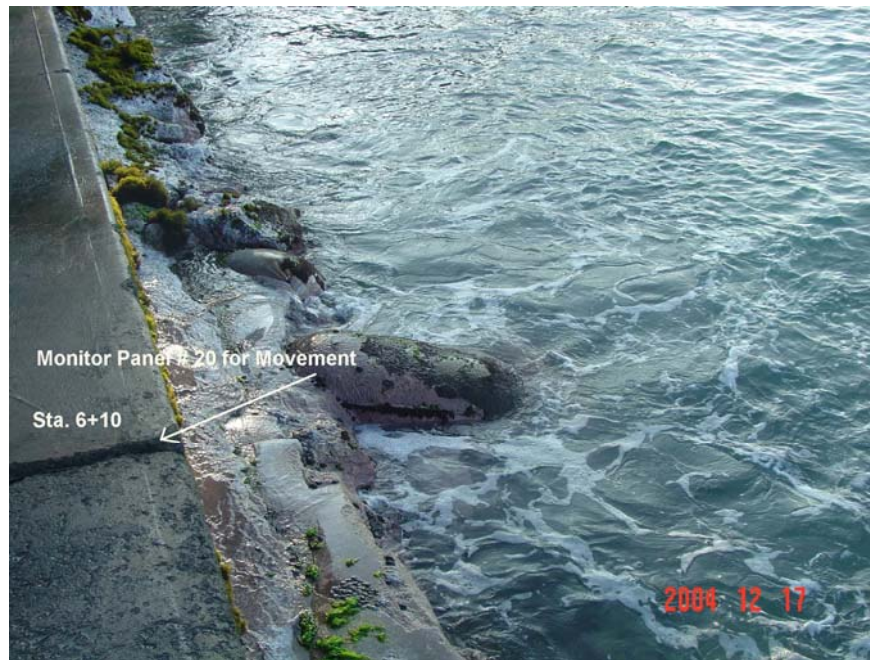
- k. Sta. 6+10, Panel # 20, monitor slight movement.

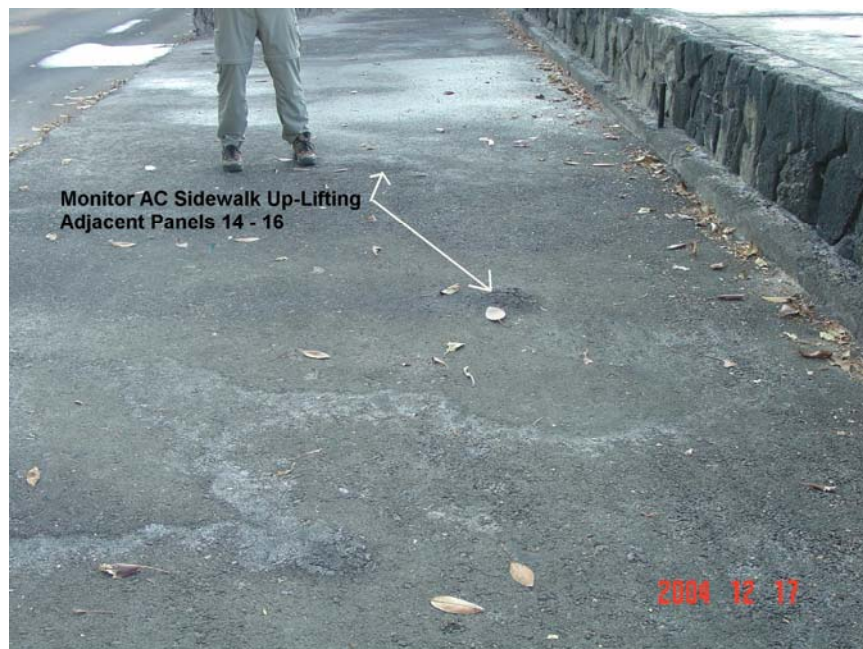
- l. Sidewalk adjacent to panels 14 thru 16, monitor uplifting.

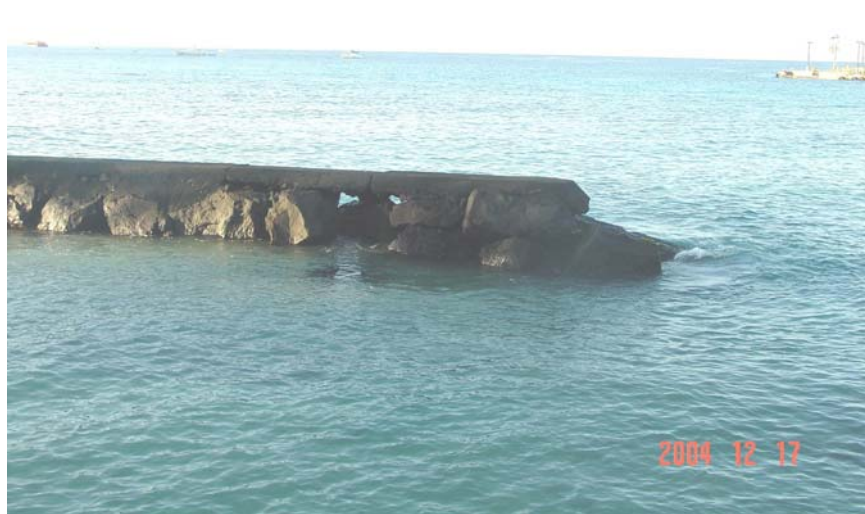
m. Reference Photo

Offshore Jetty Adjacent Sta. 7+00
Not Part of Federal Project
